Manhole Inspection Summary

Manhole # S17I__036MH

Location Address: **2328 BALTIMORE ST**

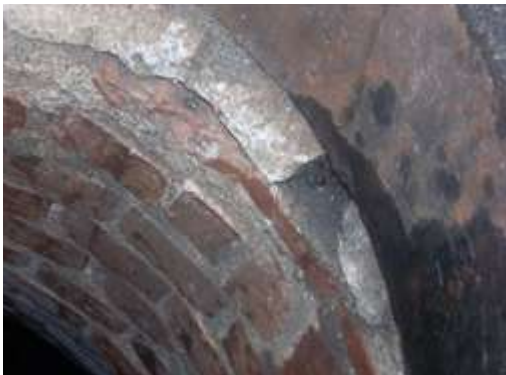
Defect 4

Condition: ☐ Sound ☐ Cracked ☐ Root Intrusion ☐ Loose Brick ☒ **Deteriorated**

CHIMNEY DETERIORATION

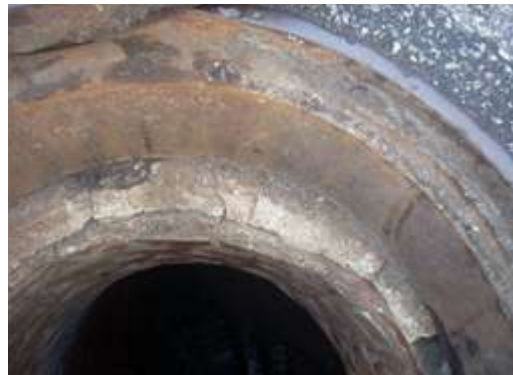
Defect 3

Offset: **2** (in.)

FRAME OFFSET

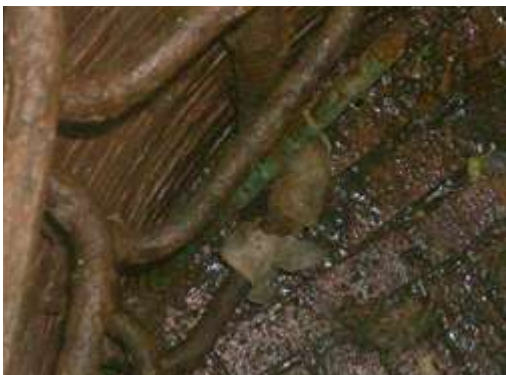
Defect 2

☒ **Evidence Of Surcharge** Depth: **2** (ft.) ☐ Active Surcharge Present

SURCHARGE EVIDENCE ON STEPS

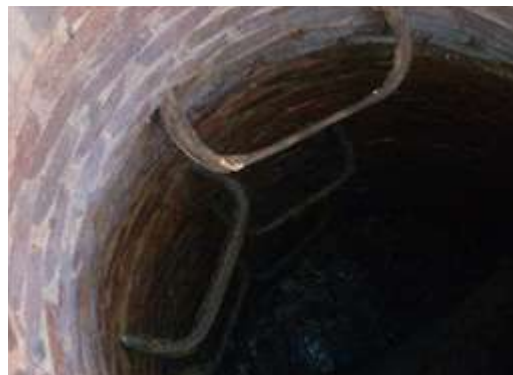
Defect 1

Count: **7** Missing: **0** ☒ **Corroded**

CORRODED STEPS

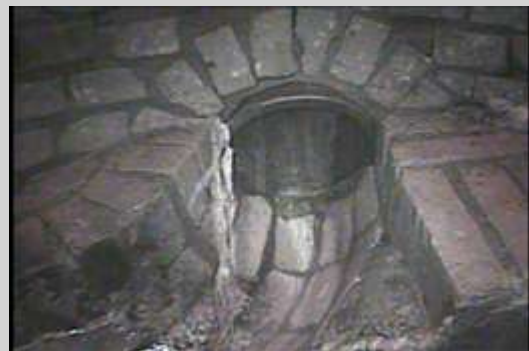
Drop In @ 3 O'Clock

Drop: **Outside** Rod and Bar
Angled: **Yes** Reading: **11.03** (ft.)
Inv Depth: **12.03** (ft.)
Drop Condition: **Open**
